Quest Engineering & Failure Analysis, Inc.
www.quest-engineering.com

Re: FR26 Report

File: Bryson Accident
Quest No: 10519

This report presents background information, our observations, analysis, and opinions regarding the subject accident. The purpose of our work was to reconstruct the subject accident. Of specific interest was investigation into the effect of the accident truck's lift modifications.

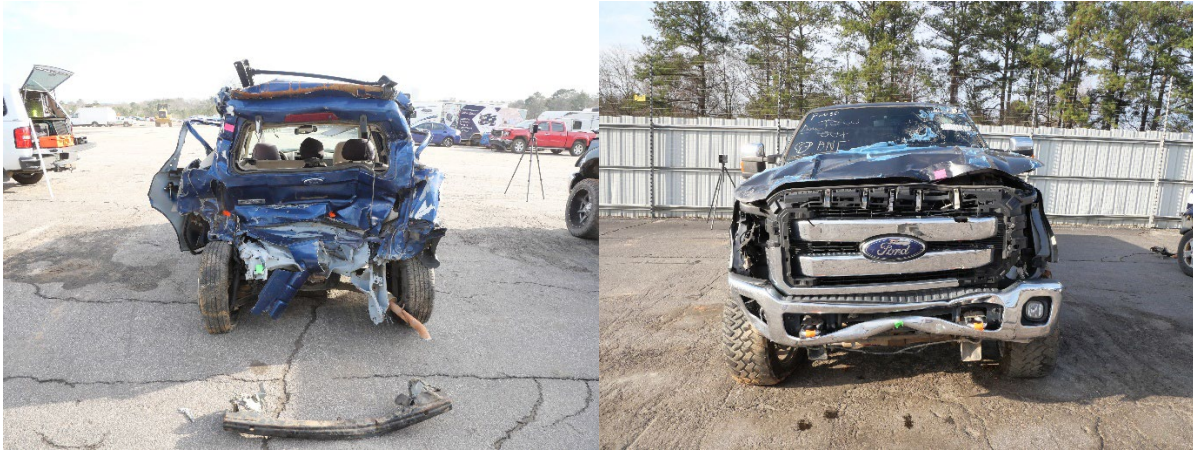
- Impact damage was present on the rear of the Escape demonstrating crush and match points between the F250's:
 - Bumper to Escape hatch
 - Tow hooks to Escape hatch

Figure 1: Match points with brightly colored tape

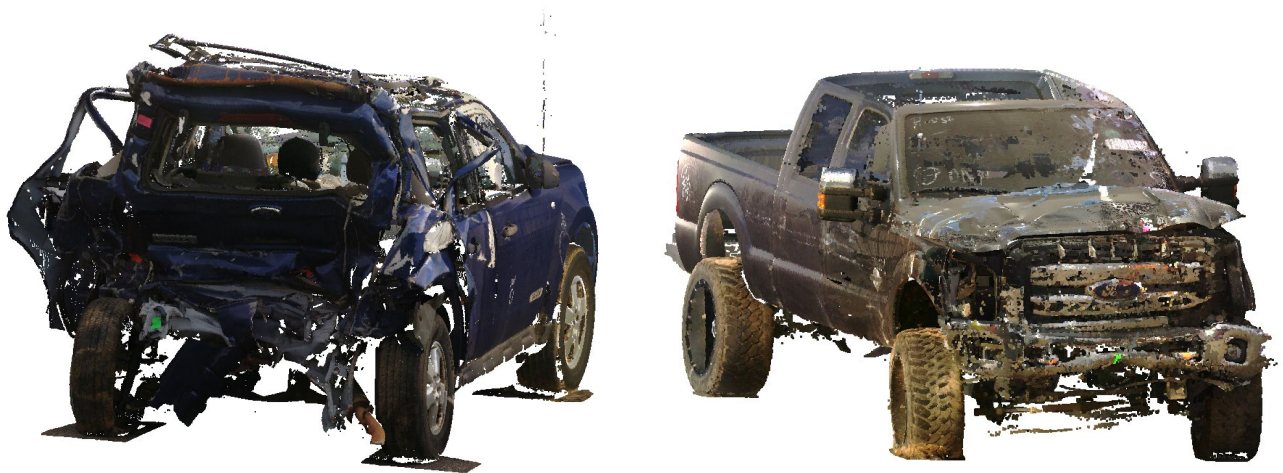
Figure 2: Brightly colored tape visible on the point cloud models

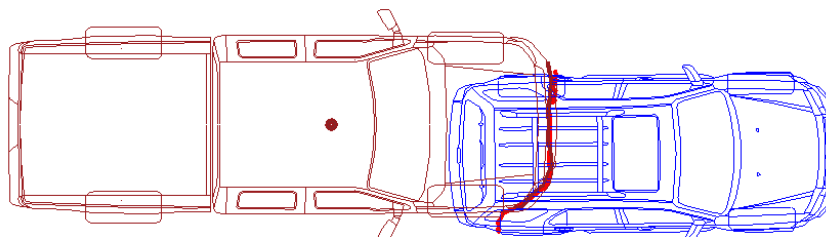
The point clouds from the inspections were imported into a CAD software called AutoCAD. In this software, a cross section of a scan can be created at any desired height level, such as the crush region. The crushed region of the Escape was around the bottom of the rear hatch and the F250 crush region was at the bumper level height. The cross section was then viewed in an orthographic 2D top-down view where the perimeter of the cross section can be traced, showing the shape of the permanent crush. The two vehicles were matched by using the drawings of the maximum permanent crush profile of the two vehicles at the corresponding elevation (*Figure 3*).

Figure 3: Crush Damage Matching (Static)

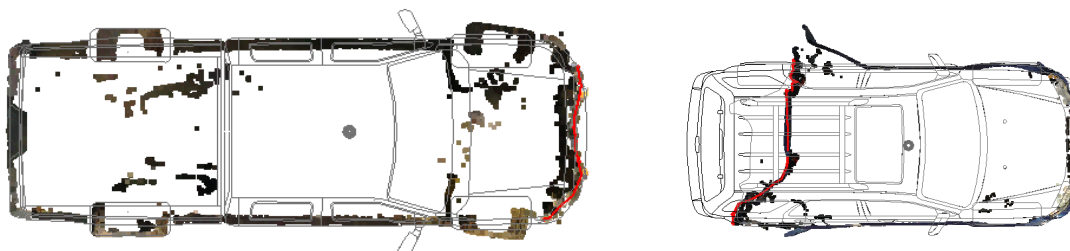
The damage profile was placed over an undamaged vehicle drawing, showing the change in the vehicle's shape (*Figure 4*). This was used to determine the amount of crush on the vehicle. In order to compare the damaged vehicle to an undamaged vehicle, an exemplar Ford F250 was inspected and scanned. The F250 inspected was a stock, unaltered, 2015 Ford F250 Super Duty Crew Cab 4x4 Pickup with LT275/70R18 tires. The exemplar was verified by using the Vehicle Identification Number (VIN). An exemplar Ford Escape, which was also stock and unaltered, was also inspected and scanned. The exemplar Escape was also scanned with an exemplar Safety 1st child seat, positioned in the rear left seat. The exemplar for the Escape was a 2010 Ford Escape 4x2 with the same size tires as the accident vehicle (235/70R16). The Escape exemplar was also verified using the VIN.

Figure 4: Crush lines from scan cross section

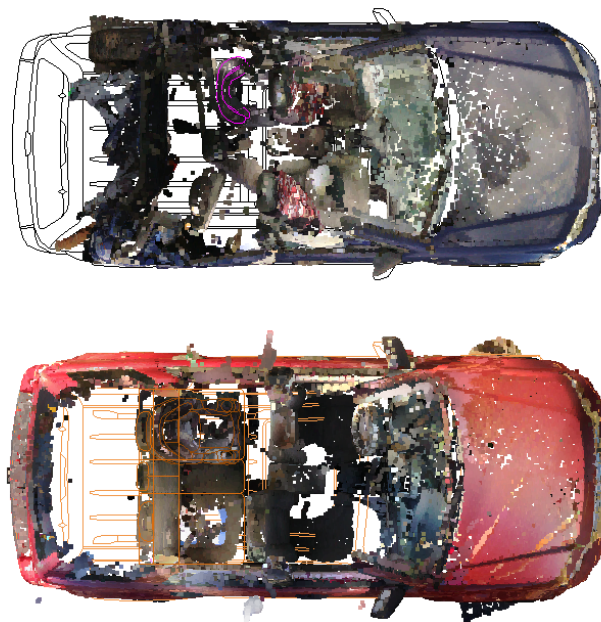
The rear seat of the Escape had been displaced forward significantly. To measure the change in forward distance that the seat had been displaced, the roofs of the subject Escape and the Escape exemplar scans were cropped, revealing the interior of the vehicles. Because the rear seat moved forward, the child seat also moved forward. The exemplar car seat was scanned in the exemplar Escape; therefore, it was visible in the cropped scan. The accident car seat no longer fit in the subject Escape. Using a 3D editing software, CloudCompare, the exemplar car seat was placed in the scan of the accident Escape based on DOA photos. This model was imported into AutoCAD and the roof was cropped, revealing the difference in the forward distance of the child seat. The movement of the head rest area and the bottom of the seat were compared (*Figure 5*).

Figure 5: Rear seat and child seat change in position

- The Escape felt a maximum of near 23.6 g's.
- The left rear occupant position had approximately 1.5 feet of forward static shift and the dynamic shift of the head rest area of the child's seat was approximately 2 feet.

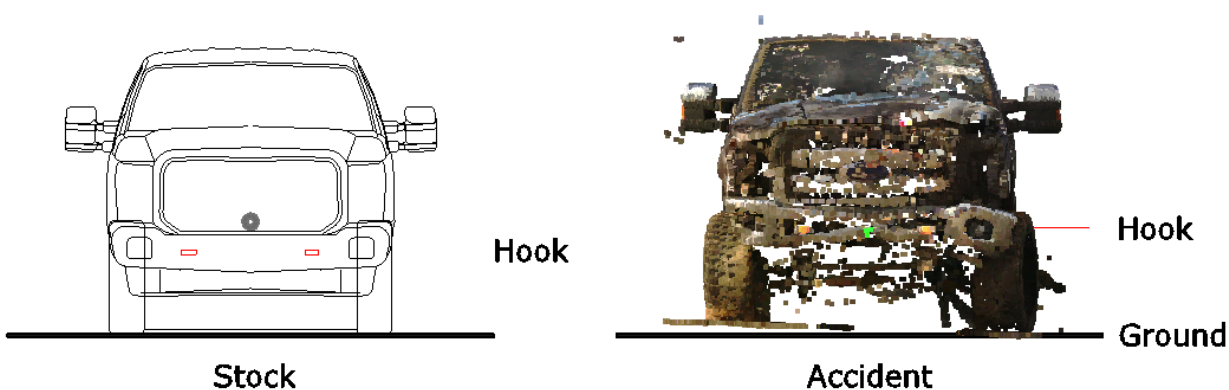
The difference in height of the F250 was determined by using side views of the F250 in AutoCAD. The scan of the exemplar (stock) F250 was drawn and the subject F250 was drawn. This revealed the height difference between the stock and lifted F250 (*Figure 6*). This was also verified by using measurements of the subject F250 and comparing against the exemplar F250.

Figure 6: Stock F250 comparison to Accident F250

- The F250 was effectively lifted over 6 inches.
- In the subject accident the F250 bumper penetrated to beyond the original location of the child seat pushing the child seat's head rest area (Safety 1st logo) forward by over 18 inches to a post-crash rest location of 1.1 feet from the rear of the driver's static seat back location.
- Dynamic analysis and damage matching reveal that during the crash the F250 bumper penetrated 4.36 feet into the rear hatch trunk and rear seat position areas, pushing the child seat's head rest area (Safety 1st logo) forward over 2 feet to a during-crash location only about 6 inches from the driver's static seat back location (top of the seat).
- Had the lift kit not been installed, the stock F250 would have interacted more directly with the stronger structural components of the Escape rear as opposed to the Escape hatch and pillars.

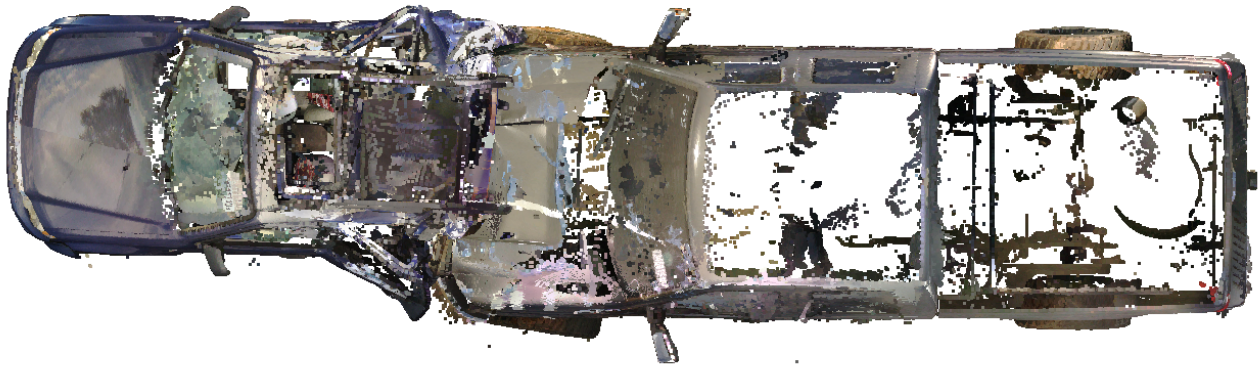
Escape displayed contact evidence. Based on the measurements, shape, and size of the markings, revealing that this was a match point. In CloudCompare, the two vehicles were matched together based on these two marks (*Figure 7*). Another match point was where the tow hooks of the F250 impacted the rear hatch of the Escape. The F250 has two tow hooks that are located near the center of the bumper. The Escape had a hole immediately to the left side of the bottom of the rear hatch and another hole that was near the right side of the centerline of the vehicle. The analysis revealed that the F250 tow hooks matched the holes of the Escape. Additional match points increased the certainty of the model.

Figure 7: Maximum Engagement modeled in 3D

A CAD comparison of the post-crash vehicle crush geometries to the deepest penetration match points revealed over ½ foot of dynamic rebound occurred. Thus, the Escape dynamic crush was determined through the comparison of known match points.
